**2. 611-PV-315B**

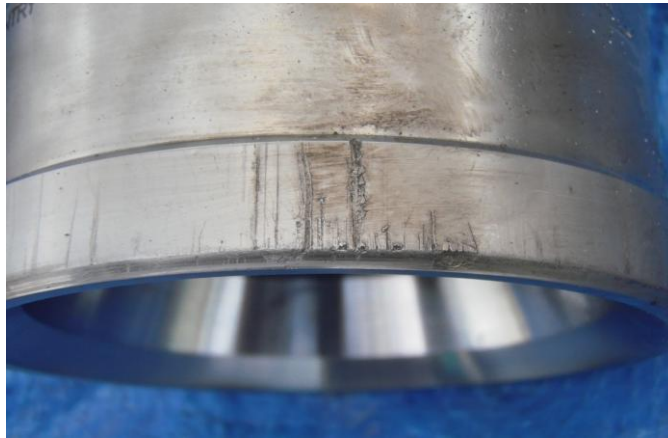
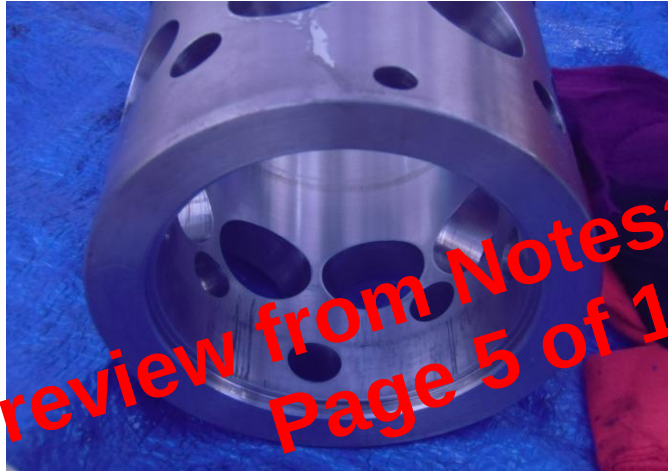
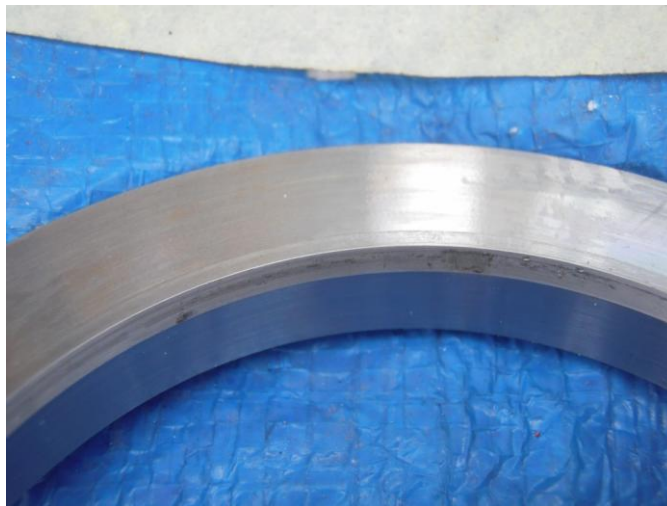
**2 . 611-PV-315B**

As Found:

1. Valve plug and cage badly scratch and pitted.
2. Seat ring had scratch and pitted.

As Left

1. Re-used existing valve trims. Only valve plug replaced with old plug .
2. Apply lapping on valve plug and seat.
3. Do cleaning with sand paper on the inner cage.
